**DEPARTMENT OF TRANSPORTATION**

Contract #: 04-0120F4Cty: SF/ALA Rte: 80 PM: 13.2/13.9File #: 1.28**WELDING INSPECTION REPORT****Resident Engineer:**Siegenthaler, Peter**Address:** 333 Burma Road**City:** Oakland, CA 94607**Report No:** WIR-024074**Date Inspected:** 31-May-2011**Project Name:** SAS Superstructure**OSM Arrival Time:** 700**Prime Contractor:** American Bridge/Fluor Enterprises, a JV**OSM Departure Time:** 1730**Contractor:** American Bridge/Fluor Enterprises, a JV**Location:** Jobsite**CWI Name:** John Pagliero**CWI Present:** Yes No**Inspected CWI report:** Yes No N/A**Rod Oven in Use:** Yes No N/A**Electrode to specification:** Yes No N/A**Weld Procedures Followed:** Yes No N/A**Qualified Welders:** Yes No N/A**Verified Joint Fit-up:** Yes No N/A**Approved Drawings:** Yes No N/A**Approved WPS:** Yes No N/A**Delayed / Cancelled:** Yes No N/A**Bridge No:** 34-0006**Component:** SAS OBG**Summary of Items Observed:**

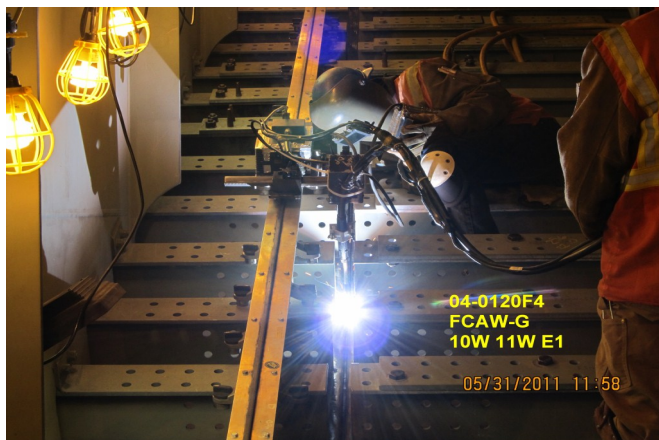
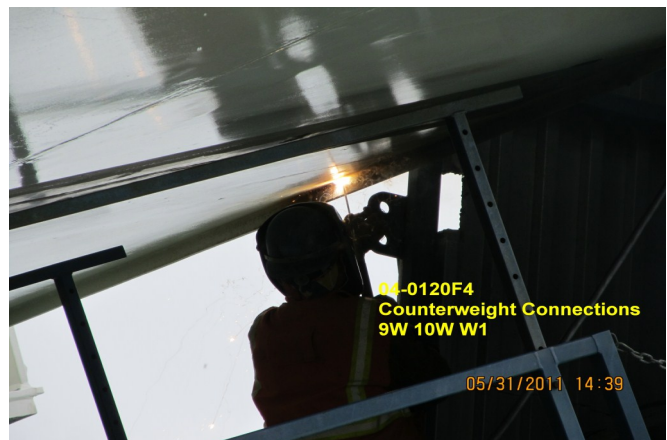
At the beginning the shift the QA Inspector met with QC Inspector John Pagliero and discussed the welders assignments and locations for the shift to include pending issues, ongoing work and required testing. ABF welder Darcel Jackson was to begin welding the retrofit of the 10mm plates on the underside of the "B" plate. The QA and the QC Inspector met with ABF welding Foreman Eric Sparks and the QC Inspector to request the WPS and pertaining details for the retrofit work being performed. The ABF Foreman stated that he would provide the requested documents.
